Southampton to Deerfield Transmission Project
Case 24-T-0113

ENVIRONMENTAL MANAGEMENT AND CONSTRUCTION PLAN

Appendix U
Vegetation and Tree Management and Restoration Plan

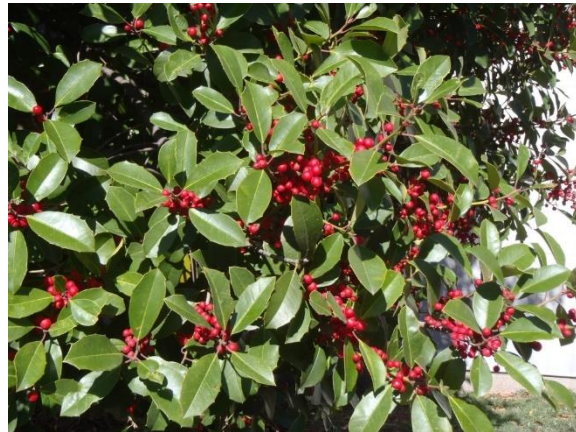
Two American holly (*Ilex opaca*) individuals are located along the Project area southwest of Southampton Substation and east of David Whites Lane. American holly trees are exploitably vulnerable under Part 6 NYCRR 193.3d. The American holly is a broadleaf evergreen with prickly green leaves measuring one to three inches in length and width.²⁰ Greenish-white flowers bloom from April to June, followed by bright red or orange drupes on female trees from September through February. Its smooth bark ranges in color from light brown and gray to white, and is occasionally reddish.

American Holly (Photo by Jim Robbins – “Greenleaf” Fruit and Leaves)

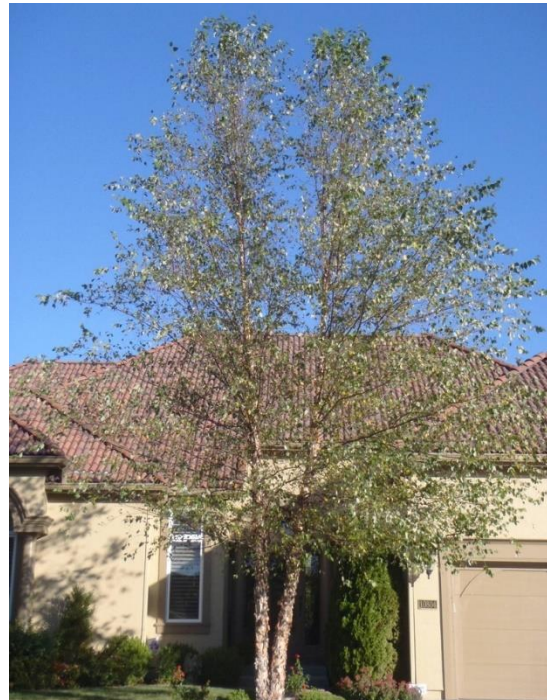
Four river birch (*Betula nigra*) individuals are located close to the Project area north of Willow Street. There are eight more individuals in the general vicinity which may experience cumulative effects if the four individuals located near the Project area decline or die. River birch trees are rare protected species under Part 6 NYCRR 193.3c. The river birch is a deciduous flowering tree known for its reddish-brown, papery bark and green leaves that measure one to three inches long and wide, turning golden yellow in the fall.²¹ As the tree matures, its bark darkens and becomes more rigid. In spring, it produces flowers that are one to three inches in size and range in color from gold to yellow and green. The tree also bears cone-like catkins that are one to one and a half inches long.

River Birch (Photo from Jim Robbins – “Heritage Form”)
